# Inspection Report

## SAMPLE REPORT

**Property Address:**  
YOUR HOUSE  
YOUR TOWN, PA

<b>Date:</b> 2/4/2010	<b>Time:</b> 8:55 AM	<b>Report ID:</b> FILE NUMBER
<b>Property:</b> YOUR HOUSE YOUR TOWN, PA	<b>Customer:</b> SAMPLE REPORT	<b>Real Estate Professional:</b>

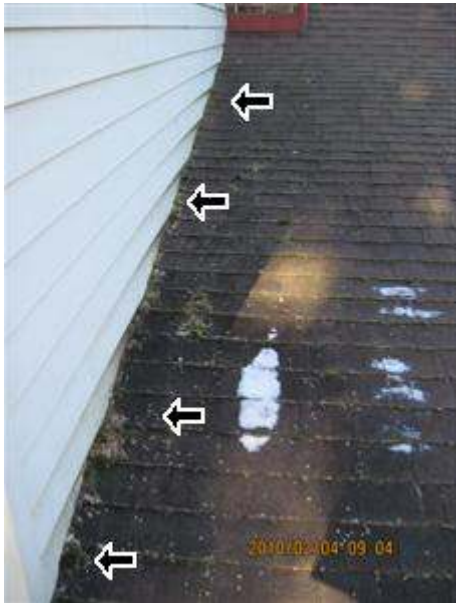
1.3 Picture 1

SEAL OR REPLACE ( 3 ) TORN PLUMBING VENT COLLAR(S).

NOT REFLASHED WITH ROOF-OVER. RE-SEAL AT SIDING EDGES

1.3 SEAL FLASHINGS EVERY 3 TO 5 YEARS.

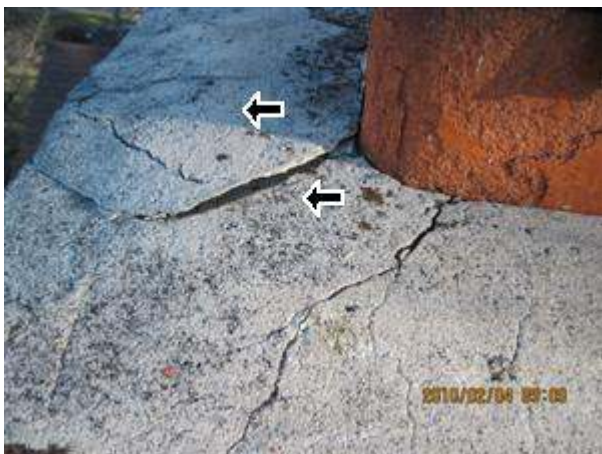
1.4 Picture 1

1.4 CHIMNEY INTERIOR CAN ONLY BE INSPECTED BY A SERVICE COMPANY. RESEAL/REBUILD CHIMNEY CROWN.

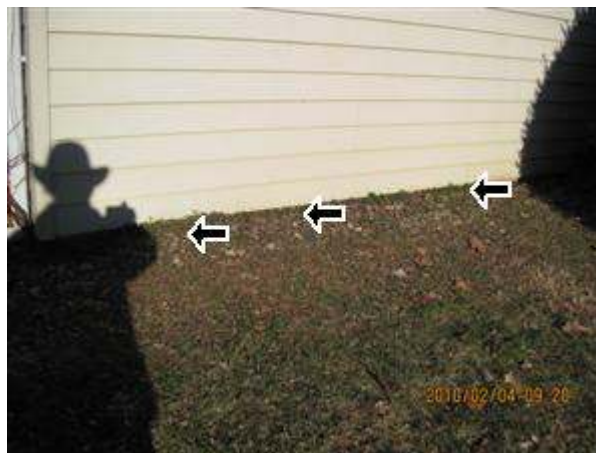
2.0 Picture 1

2.0 CAULK/SEAL GAPS AT CHIMNEY-SIDING JOINTS NOW.

WOOD-SOIL CONTACT NOTED. LOWER MULCH/SOIL LEVELS.

THE BRICKWORK IS APPLIED WITHOUT BENEFIT OF WEEPHOLES OR VISIBLE FLASHING. THIS IS A COMMON DEFECT, AND USUALLY DOES NOT CAUSE PROBLEMS, BUT OCCASIONALLY CAN ALLOW A BUILD-UP OF MOISTURE BEHIND THE BRICK VENEER THAT CAN CAUSE HIDDEN DAMAGE/DETERIORATION TO DEVELOP.

KEEP ANY EXTERIOR HOUSE WOOD ELEMENTS PAINTED OR SEALED.

SEAL ALL PENETRATIONS FOR WIRING AND PLUMBING.

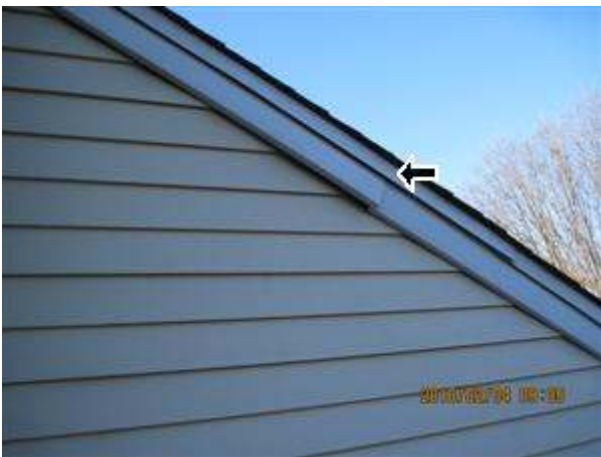
2.1 Picture 1

RESET ALL LOOSE CAPPING NOTED: UPPER LEFT SIDE.

2.1 KEEP ALL EXTERIOR HOUSE WOOD ELEMENTS PAINTED OR SEALED.

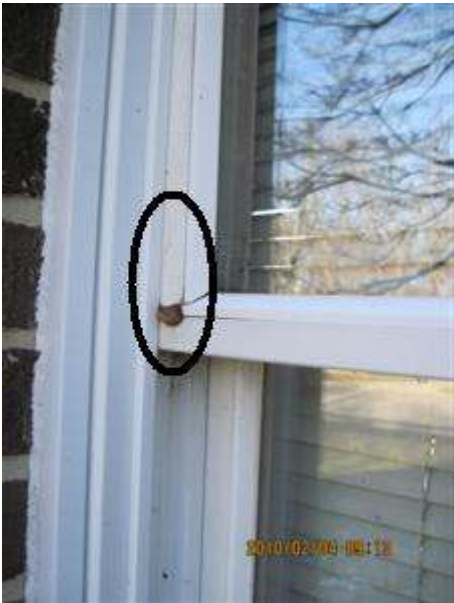
2.3 Picture 1

REPLACE DETERIORATED WINDOW SASH NOTED: (2) AT GARAGE

2.3 OBTAIN SCREEN INVENTORY BEFORE SETTLEMENT.

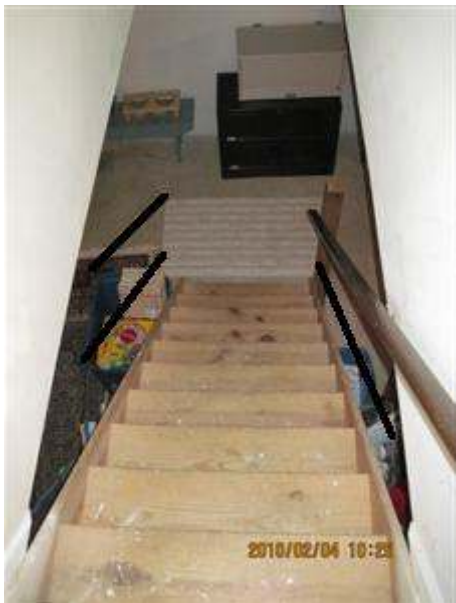
10.3 Picture 1

**10.3** ADD GUARD RAILING(S) AT OPEN SIDE(S) FOR SAFETY.

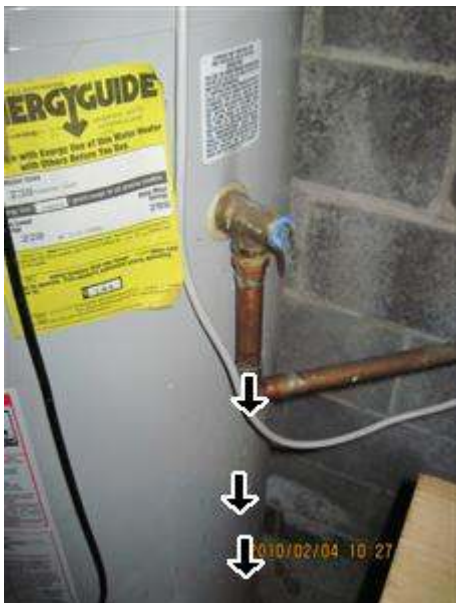
13.5 Picture 1

**13.5** PIPE RELIEF VALVE WITHIN 6" OF FLOOR. PLAN FOR AGE-RELATED REPLACEMENT.

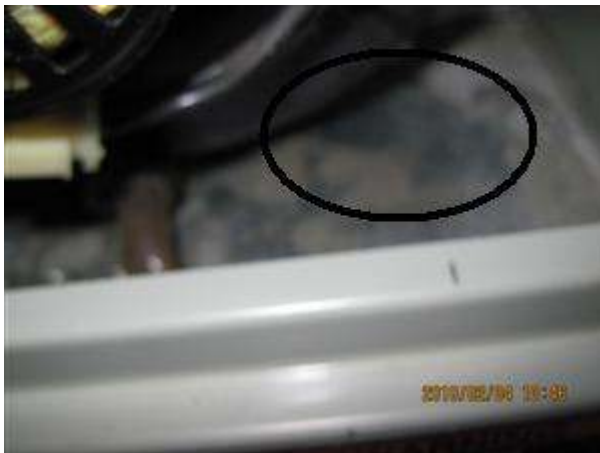
14.0 Picture 1

EVIDENCE OF CONDENSATE LEAKAGE NOTED IN HIGH-EFFICIENCY FURNACE.

-- HAVE SERVICE COMPANY CLEAN, ADJUST AND EVALUATE UNIT PRIOR TO SETTLEMENT.

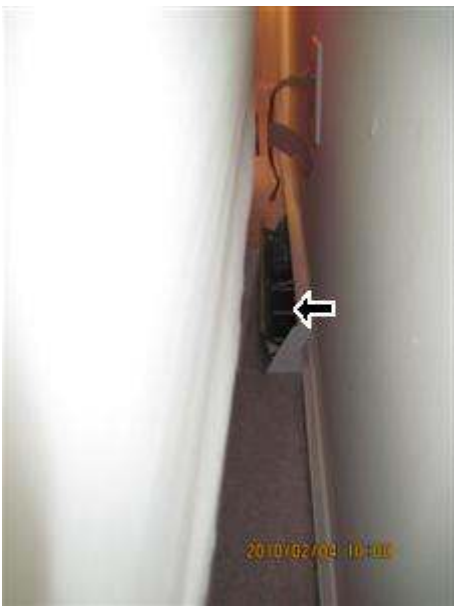
14.5 Picture 1

**14.5** DUCT CLEANING IS RECOMMENDED. REMOVE HUMIDIFIER. INSTALL ALL MISSING DUCT REGISTERS.
